**MARKER No. 05: MARLIN PARSONS (d. 1850)**

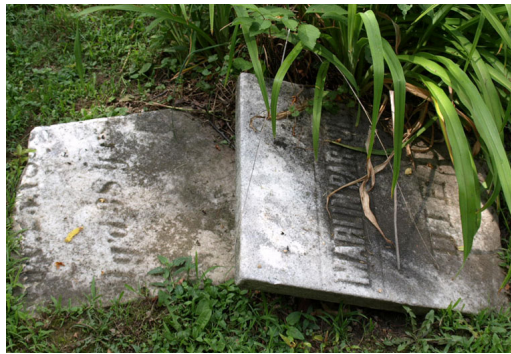
*Before (July 2009)*

- The marble headstone is in poor condition: it is broken in half with the lower portion partially buried.
- The marble is experiencing slight surface erosion and biological growth and staining, however, the inscriptions are legible.
- No visible evidence of a sandstone base.
