MARKER No. 21: CAROLINE HICKOX (d. 1817) wife of Giles Hickox

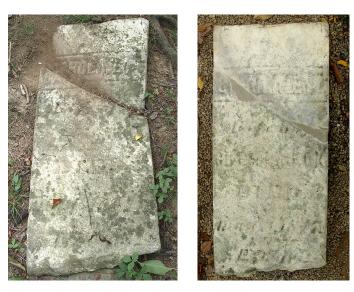
- The marble marker is in poor condition. The marker is lying on the ground, partially buried and broken into two fragments. The marker is fractured through the name inscription at the upper portion; the marble is also being affected by surface erosion and the inscriptions are not clearly legible.
- The lower portion of the marker is missing.
- The marker is experiencing biological growth and staining and is surrounded by tree roots just above the surface of the ground.
- No visible evidence of an original sandstone base.

- A. Excavation/Fragment Recovery
 - Carefully excavate partially-buried marble headstone fragments.
 ▶lower fragment not found.
 - 2. Selectively cut back tree roots and excavate for resetting headstone.

- 3. Search for sandstone base.
 - ► base fragments not found.
- B. Cleaning
 - 1. For removal of biological growth and general soiling, clean the marble headstone fragments with D/2 Architectural Antimicrobial.

- a. Clean water at low pressure (max 400 psi) and hand-pump sprayer.
 - b. Natural and nylon bristle brushes (varying stiffness and size).
 - c. Avoid dissolution or erosion of the stone.

- C. Re-attachment and Repair
 - 1. Re-attach two marble headstone fragments using two-part stone epoxy and threaded brass rods.
 - 2. Point and infill where necessary around attachment seam with custom-mixed, lime-based, marble repair mortar.

- D. Reset and Level
 - 1. Reset headstone at the proper level in the ground in a mix of fine gravel, sand, cement, and hydrated lime.
 - a. Place brick or pieces of stone in hole for additional support.

- ► because the lower portion of the marker was not found, and due to the extensive root growth, the two re-attached portions of the marker were set in a horizontal position on a bed of gravel and sand.

- E. Site Preparation and Repair
 - 1. Place pea gravel around base
