MARKER No. 12: ? DYER (d. 1856) daughter of D. & S. Dyer

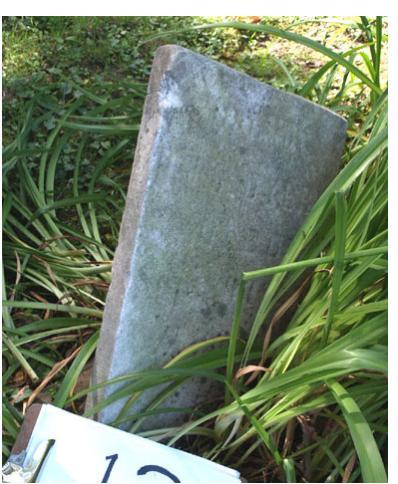
- The marble headstone is in poor condition: it is experiencing biological growth and staining and the inscriptions are not clearly legible.
- The headstone appears to be broken in half, with the lower portion lying on the ground and the upper loosely set in a damaged sandstone base. The lower fragment is weathered at the fracture line.
- The marker is surrounded by vegetation and the exact condition of the sandstone base is unknown.

- A. Excavation/Fragment Recovery
 - 1. Carefully remove marble headstone and sandstone base (and fragments).
 - 2. Cut back vegetation.
- ► the match to the lower marker fragment was not located.
- ► found intact sandstone base.
- B. Cleaning
 - 1. For removal of biological growth and general soiling, clean the marble headstone and sandstone base with D/2 Architectural Antimicrobial.
 - a. Clean water at low pressure (max 400 psi) and hand-pump sprayer.
 - b. Natural and nylon bristle brushes (varying stiffness and size).
 - c. Avoid dissolution or erosion of the stone.
- C. Re-attachment and Repair
 - 1. Attempt to re attach lower marble headstone fragment using two part stone epoxy and threaded brass rods.

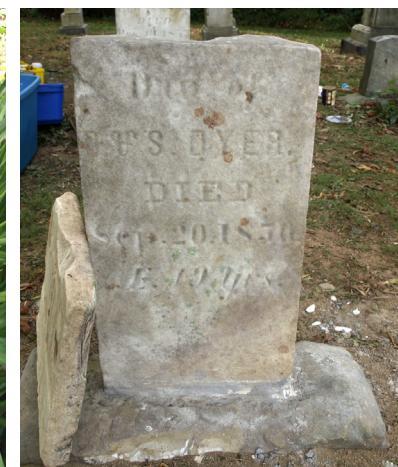
After (September 209)

► the small marble fragment (*Elmira*) does not appear to be a match to the larger, lower portion, therefore, the fragments were not re-attached. The *Elmira* fragment was laid against the re-set marker.

2. Point and patch marble headstone where necessary with custom mixed, lime based, marble repair mortar.

3. Repair sandstone base.

► cut new notch (mortise) in found sandstone base.

- D. Reset and Level
 - 1. Reset and level sandstone base upon compacted gravel.
 - 2. Reset and plumb marble headstone [fragment] into slotted sandstone base with Type O mortar. Point resultant joint with Type O mortar.
- E. Site Preparation and Repair
 - 1. Place pea gravel around base
