MARKER No. 10: HAMILTON (d. 1862)

EXISTING CONDITIONS

TREATMENT SUMMARY

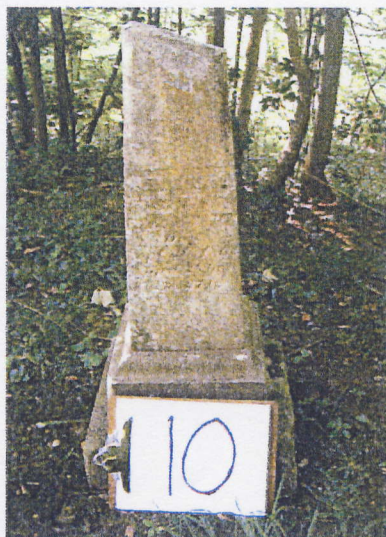
Before (July 2008)

- The uppermost portion of the marble obelisk has broken off and is missing, and the obelisk is loose from its marble plinth.
- What remains of the obelisk is in good/fair condition and the inscriptions are partially legible.
- Epoxy from a previous repair attempt remains around the fracture area of the obelisk.
- The marble contains biological growth and slight staining.
- Sandstone base is in good condition with biological growth and slight staining.
