## MARKER No. 11: EZEKIEL T. JOHNSON (d. 1859)

### EXISTING CONDITIONS

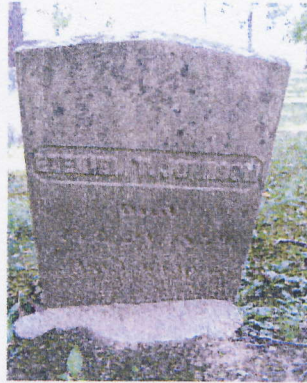
*Before (July 2008)*

- The marble headstone is in good condition and the inscriptions are legible. The headstone is not currently set in a solid base and is leaning over.
- The headstone is experiencing biological growth and slight staining.
- There are broken concrete berms at the base of the headstone.
- No evidence of a base is visible.

1. Remove concrete berms from marble headstone.
2. Remove headstone from ground.
3. Search for base.
  - ▶ base not found.

1. For removal of biological growth and general soiling, the marble headstone is to be cleaned with D/2 Architectural Antimicrobial.
  - a. Clean water at low pressure (max 300 psi) and hand-pump sprayer.
  - b. Natural or nylon bristle brushes (varying stiffness and sizes).
  - c. Avoid dissolution or erosion of the stone.
    - ▶ stone was successfully cleaned, however, slight biological staining and discoloration remain, which cannot be removed without harsh methods.

1. Reset marble headstone in the ground, at proper depth, in a mixture of gravel, sand, cement and hydrated lime.
  - ▶ pieces of stone placed in bottom of hole for foundation.

1. Place pea gravel around base.
