## MARKER No. 17: THOMAS MINER (d. 1858)

### EXISTING CONDITIONS

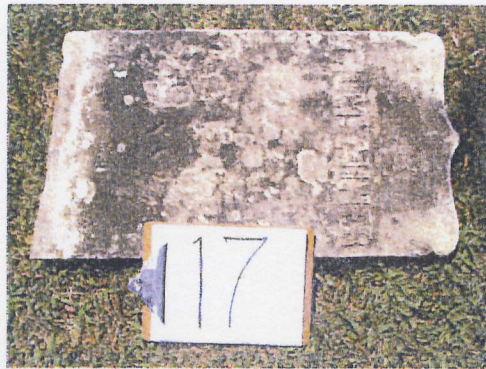
*Before (July 2008)*

- The marble headstone is in fair/poor condition and the inscriptions are partially legible. The headstone is experiencing slight surface erosion.
- The marker is not set in a base and is lying near the contemporary Miner family monument. At this time, the original location of the marker is unknown.
- The headstone contains biological growth and staining.
- No evidence of a base is visible.

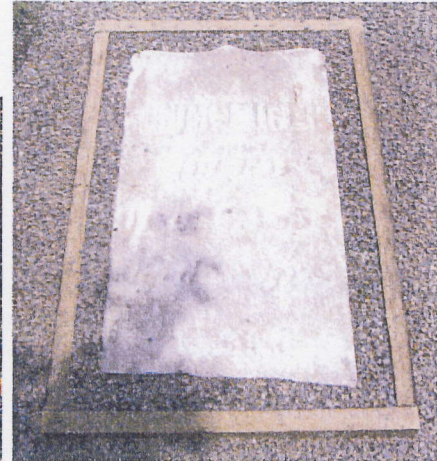
*After (May 2009)*

▶ stone was successfully cleaned, however, very slight biological staining and discoloration remain, which cannot be removed without harsh methods.

1. For removal of biological growth and general soiling, the marble headstone was cleaned with D/2 Architectural Antimicrobial.
  - a. Clean water at low pressure (max 300 psi) and hand-pump sprayer.
  - b. Natural or nylon bristle brushes (varying stiffness and sizes).
  - c. Avoid dissolution or erosion of the stone.

1. Set marble headstone in a frame constructed of 2x4 treated lumber. The bottom of the frame shall be lined with geofabric and filled with a mixture of pea gravel, sand and lime; which the headstone will be set in. This arrangement shall be located just to the north of the contemporary Miner monument, on as level of ground that can be found.

- ▶ a small amount of sod and soil was removed to provide "level" ground.
