## MARKER No. 02: JOHN KENNEDY (d. 1867)

### EXISTING CONDITIONS

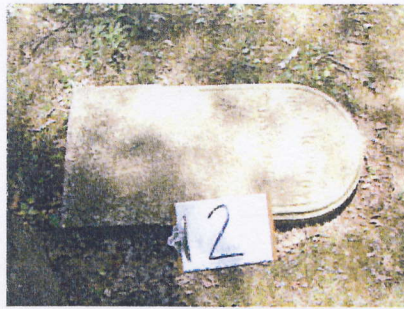
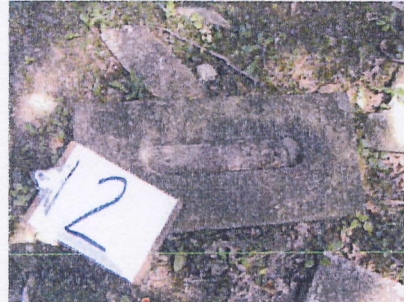
Before (July 2008)

- Marble headstone is detached from its sandstone base and lying on the ground in a horizontal position next to the base.
- The headstone's tenon which fits into the slotted base has broken off, yet appears to be salvageable.
- The headstone is stained and contains biological growth, however, it is in good condition.
- The sandstone slotted base is in good condition with slight staining and biological growth.

1. Excavate partially-buried headstone and tenon fragments.

1. For removal of biological growth and general soiling, the marble headstone and sandstone base were cleaned with D/2 Architectural Antimicrobial.
  - a. Clean water at low pressure (max 300 psi) and hand-pump sprayer.
  - b. Natural and nylon bristle brushes (varying stiffness and size).
  - c. Avoid dissolution or erosion of the stone.

► stones were successfully cleaned, however, very slight biological staining and discoloration remain, which cannot be removed without harsh methods.

1. Re-attach marble tenon to headstone using two-part epoxy and threaded stainless steel rods.
  - fragment re-attachment clamped in place for 12 hrs.
  - resultant crack and minor losses pointed with custom mixed Type O mortar (lime-based, with marble dust).

1. Reset and level sandstone base upon compacted gravel.
2. Reset and plumb marble headstone into slotted sandstone base with a Type O mortar mix.
  - binder-rich mortar (slurry) placed in bottom of slot and joint pointed with Type O mortar.

1. Place pea gravel around base
