MARKER No. 04: NATHAN KENNEDY (d. 1844) son of J&H Kennedy

TREATMENT SUMMARY

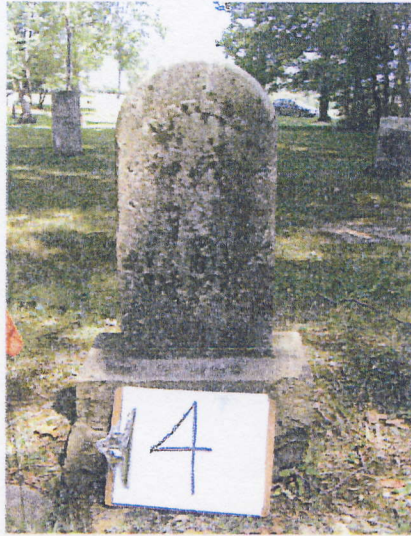
Before (July 2008)

- The Marble headstone is experiencing biological growth and slight staining, however, it is in good condition and remains attached to its sandstone base.
- The sandstone base has been displaced from the ground and is fully exposed.

- ▶ lift sandstone base with headstone intact.

1. For removal of biological growth and general soiling, the marble headstone and sandstone base were cleaned with D/2 Architectural Antimicrobial.
 - a. Clean water at low pressure (max 300 psi) and hand-pump sprayer.
 - b. Natural or nylon bristle brushes (or varying stiffness and sizes).
 - c. Avoid dissolution or erosion of the stone.
 - ▶ the marble headstone was cleaned with slight success: biological staining and discoloration remain.
 - ▶ it is recommended that additional cleaning efforts be carried out (test different products and methods).

1. Reset the marker to proper depth, level and plumb, upon compacted gravel.

1. Place pea gravel around base.
