**MARKER No. 02: WALTER CREES. (d. 1908)**

**EXISTING CONDITIONS**

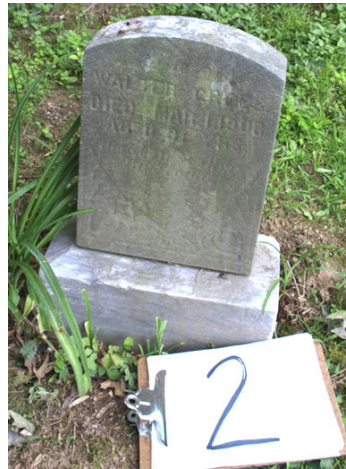
*Before (July 2009)*

- The marble headstone and base are in good condition.
- The marble headstone and base are stained and contain biological growth.
- The marker has settled and is no longer plumb and level.

- A. Excavation/Fragment Recovery
1. Remove marker from ground.
  2. Excavate for new compacted gravel foundation.
- B. Cleaning
1. For removal of biological growth and general soiling, the marble headstone and base are to be cleaned with D/2 Architectural Antimicrobial.
    - a. Clean water at low pressure (max 400 psi) and hand-pump sprayer.
    - b. Natural or nylon bristle brushes.
    - c. Avoid dissolution or erosion of the stone.
- C. Re-attachment and Repair
- D. Reset and Level
1. Reset the base to proper depth, level and plumb, upon a new compacted gravel foundation.
  2. Reset the headstone to the base upon a thin bed of lime-based mortar and an outer bead of setting compound.
- E. Site Preparation and Repair
1. Place pea gravel at base of marker.
