**MARKER No. 03: ELIZABETH S. BUTLER (d. 1855) wife of Benjamin Butler**

**EXISTING CONDITIONS**

**TREATMENT SUMMARY**

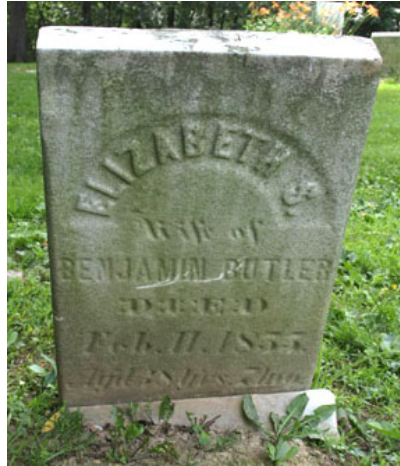
- The marble headstone is in good condition, however, it is experiencing slight staining and biological growth.
- The headstone is not attached to a base and is leaning on a small marble footstone. Source of marble footstone not known.
- No visible evidence of an original sandstone base.

*Before (July 2009)*

1. Carefully excavate marble headstone and footstone.
2. Search for sandstone base.
  - ▶ located fragment.
3. Search for source and original location of marble footstone.
  - ▶ marble footstone foreign to this location.

1. For removal of biological growth and general soiling, the marble headstone and footstone are to be cleaned with D/2 Architectural Antimicrobial.
  - a. Clean water at low pressure (max 400 psi) and hand-pump sprayer.
  - b. Natural or nylon bristle brushes.
  - c. Avoid dissolution or erosion of the stone.

1. Reset headstone at the proper level in the ground in a mix of fine gravel, sand, cement, and hydrated lime.
  - ▶ sandstone base fragment placed on grade at front side of marker.
2. ~~If its location is determined, reset marble footstone as described in D-1.~~
  - a. ~~Place brick or stone pieces in hole for additional support.~~

1. Place pea gravel at base of marker.

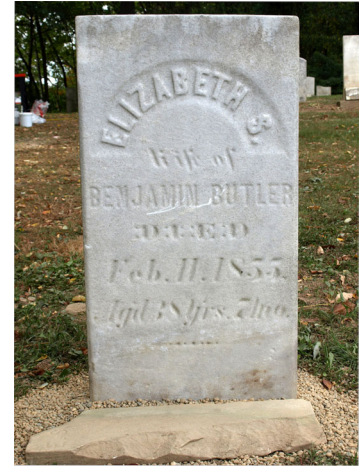
*After (September 2009)*
