MARKER No. 04: FRIZZELL MONUMENT – L. Frizzell:1885; Harriet:1878; Henry G:1862; Sylvia: 18*7

TREATMENT SUMMARY

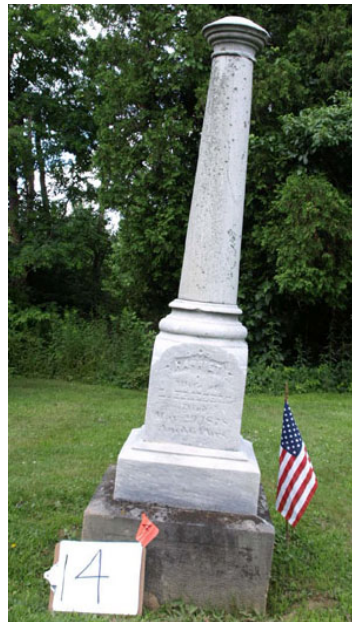
Before (July 2009)

- The marble obelisk is in good/fair condition.
- The marble obelisk is experiencing minor surface erosion, biological growth and staining, and some minor chips and losses at edges. There is a fine vertical crack in the shaft which appears to be the result of inherent geological properties and weathering.
- The marble finial is missing and there are remnants of previous epoxy repairs between marble base and plinth.
- The sandstone base is in good condition and is experiencing biological growth and staining.
- The entire monument is settling (sinking) and leaning to the east. The monument is leaning at an extreme that is producing the potential for toppling over.
