MARKER No. 06: MARY BONNEL (d. 1861) wife of David Bonnel

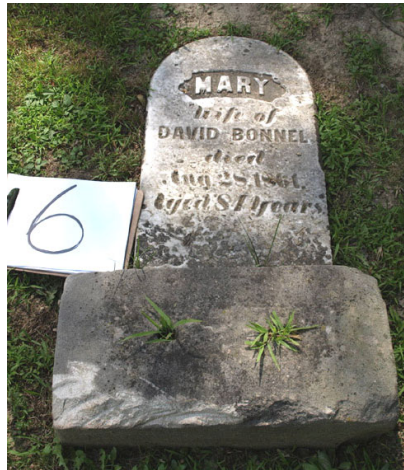
Before (July 2009)

- The marble headstone is in good/fair condition, however, it is experiencing slight surface erosion and biological growth and staining.
- The marble headstone is no longer on its sandstone base and is partially buried in a horizontal position next to the base.
- The sandstone base is in good condition with slight discoloration and biological growth. The southeast corner has been damaged by mower. The original pin holes are evident and can be utilized.

- A. Excavation/Fragment Recovery
1. Carefully remove marble headstone from ground.
- B. Cleaning
1. For removal of biological growth and general soiling, the marble headstone and sandstone base are to be cleaned with D/2 Architectural Antimicrobial.

- a. Clean water at low pressure (max 400 psi) and hand-pump sprayer.
 - b. Natural or nylon bristle brushes.
 - c. Remove debris from existing pin holes (both headstone and footstone).

- d. Avoid dissolution or erosion of the stone.
 2. Remove debris from pin holes.
▶additional cleaning was carried out with a diluted solution of Kodak Photo-Flo 200.

- C. Re-attachment and Repair
- D. Reset and Level
1. Reset marble headstone upon exiting sandstone base with setting compound and threaded stainless steel pins.

- a. The new stainless steel pins will be inserted in existing holes with lime-based grout.
▶the new stainless steel pins were set in marble headstone with two-part stone epoxy.
