MARKER No. 09: “THANKFUL” (d. 1845) wife of R. Abell Esq.

EXISTING CONDITIONS

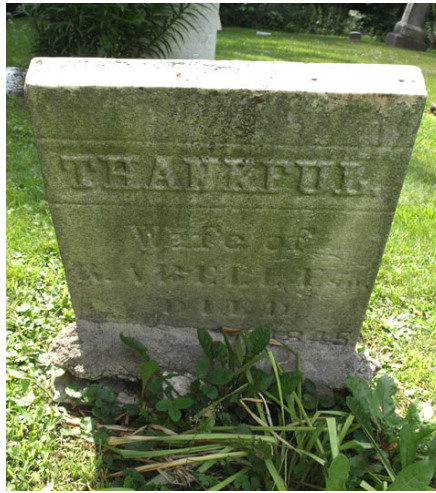
Before (July 2009)

- The marble headstone is in good condition and the inscriptions are legible. The headstone is not currently set in a solid base and is leaning over. There are broken concrete berms at the base of the headstone.
- The headstone is experiencing biological growth and slight staining.
- No visible evidence of a sandstone base.
