MARKER No. 10: LIBBIE BENNETT (d. 1869) wife of Charles Bennett

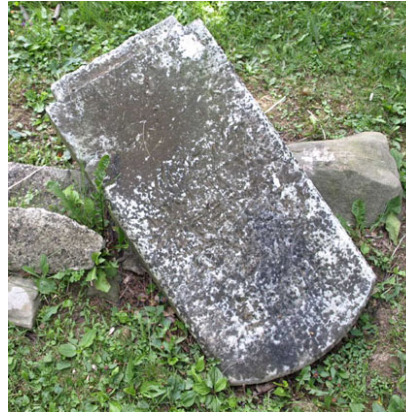
Before (July 2009)

- The marble headstone is in sound condition, however, it is experiencing biological growth and severe staining (marble headstone has a tenon for attachment to its base).
- The headstone is also experiencing surface erosion and the inscriptions are not clearly legible (due in part to the biological growth and staining).
- The marble headstone is detached from its original slotted sandstone base and is lying cantoned on the ground on what appears to be fragments from its original sandstone base.

1. Remove marble headstone to a safe location for cleaning.
2. Excavate buried sandstone base fragments.
 - ▶ located foreign sandstone base fragments.
 - ▶ located intact sandstone base.

1. For removal of biological growth and general soiling, clean the marble headstone and sandstone base fragments with D/2 Architectural Antimicrobial.
 - a. May require additional stone cleaning products (neutral) and multiple applications.
 - b. Clean water at low pressure (max 400 psi) and hand-pump sprayer.
 - c. Natural and nylon bristle brushes (varying stiffness and size).
 - d. Avoid dissolution or erosion of the stone.
 - ▶ additional cleaning was carried out with a diluted solution of Kodak Photo-Flo 200.

1. Re-attach sandstone base fragments using two-part stone epoxy and threaded stainless steel rods where necessary.
 - ▶ a new slot (mortise) was cut into the found sandstone base.

1. Reset and level repaired sandstone base upon compacted gravel.
2. Reset and plumb marble headstone into slotted sandstone base with a Type O mortar mix (~~use threaded stainless steel rods if necessary~~). Point surrounding joint with Type O mortar.

- ~~1. Place pea gravel around base~~
 - ▶ the area around the base was raked and graded.
