MARKER No. 11: EUNICE BENNETT (d. 1869) daughter of Charles & Libbie Bennett

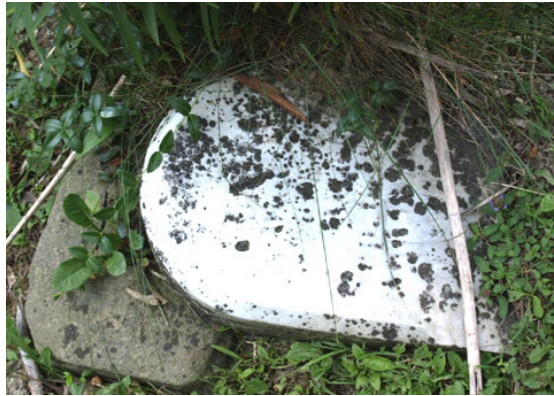
Before (July 2009)

- The marble headstone is in sound condition, however, it is experiencing biological growth and staining.
- The headstone is also experiencing surface erosion and the inscriptions are not clearly legible (due in part to the biological growth and staining).

- The marble headstone is detached from its original sandstone base and lies partially buried on what appears to be its original sandstone base (the marble headstone was originally attached with two metal pins).
- The sandstone base appears to be in sound condition with minor surface erosion, biological growth and staining. The base retains two holes from where the headstone was attached with pins.

1. Carefully excavate partially-buried marble headstone and sandstone base.
2. Cut back vegetation.

1. For removal of biological growth and general soiling, clean the marble headstone and sandstone base with D/2 Architectural Antimicrobial.
 - a. May require additional stone cleaning products (neutral pH) and multiple applications.
 - b. Clean water at low pressure (max 400 psi) and hand-pump sprayer.
 - c. Natural and nylon bristle brushes (varying stiffness and size).
 - d. Avoid dissolution or erosion of the stone.

▶ additional cleaning was carried out with a diluted solution of Kodak Photo-Flo 200.

2. Remove debris from pin holes.

1. Reset and level sandstone base upon a new compacted gravel foundation.
2. Reset and plumb marble headstone on sandstone base utilizing existing pin holes. Use threaded stainless steel rod set in grout and set headstone on a thin bed of lime-based mortar.
