**MARKER No. 13: DAVID B. DYER (d. 1862) Civil War veteran – died in battle**

**EXISTING CONDITIONS**

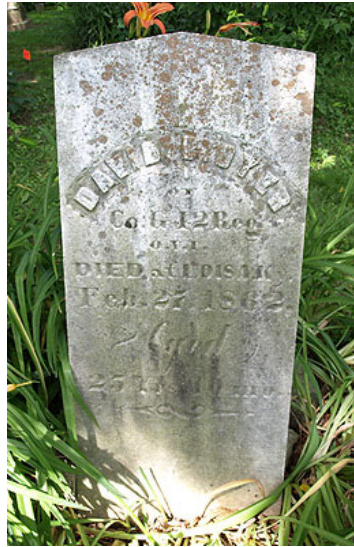
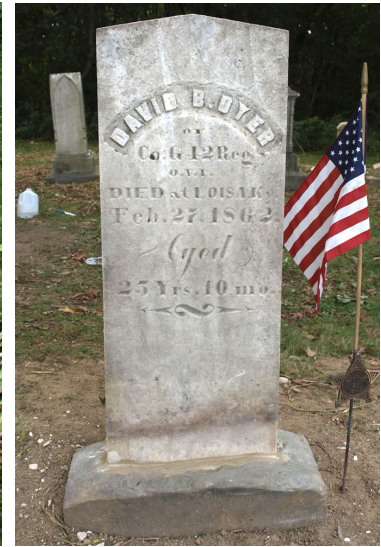
- The marble headstone is in good condition, however, it is experiencing slight biological growth and staining. The inscriptions are legible.
- The marble headstone is no longer set in its sandstone base and is currently leaning to the west and shored up with concrete berms.
- It appears that at least part of the sandstone base remains in the ground behind the headstone.
- The marker is surrounded by vegetation and the exact condition of the sandstone base is unknown.

1. Carefully remove marble headstone and sandstone base.
2. Cut back vegetation.
3. Search for sandstone base fragments.
  - ▶ found intact sandstone base.

1. For removal of biological growth and general soiling, clean the marble headstone and sandstone base fragments with D/2 Architectural Antimicrobial.
  - a. Clean water at low pressure (max 400 psi) and hand-pump sprayer.
  - b. Natural and nylon bristle brushes (varying stiffness and size).
  - c. Avoid dissolution or erosion of the stone.

- ~~1. If sandstone base fragments are recovered, re-attach using two-part stone epoxy and threaded stainless steel rods.~~
  - ~~a. Point resultant joints and loses with custom mixed lime based mortar.~~
    - ▶ a complete, intact, sandstone base was found and utilized.
    - ▶ cut new notch (mortise) in found sandstone base.
    - ▶ carefully remove concrete berms from marble marker.

1. Reset and level repaired sandstone base upon a new compacted gravel foundation.
2. Reset and plumb marble headstone into slotted sandstone base with Type O mortar. Point resultant joint with Type O mortar.

- ~~1. Place pea gravel around base~~
  - ▶ the area around the base was raked and graded.
