**MARKER No. 14: ???**

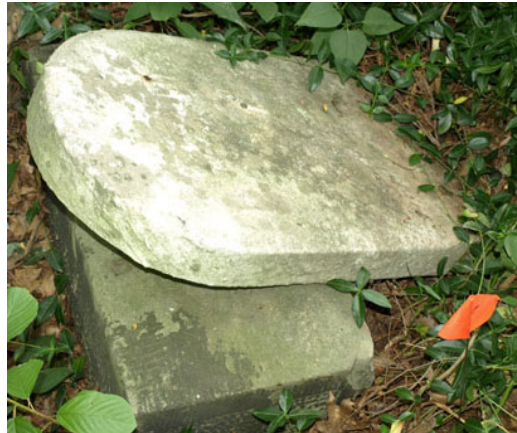
*Before (July 2009)*

- The marble headstone is in fair condition and is experiencing biological growth and staining, and minor surface erosion. The inscriptions are not clearly legible.
- The marble headstone is no longer attached to its sandstone base and is currently partially buried and leaning on its sandstone base. The headstone was originally attached to its base with two metal pins and a thin bed of mortar.
- The sandstone base appears to be in good condition with biological growth and staining.

- A. Excavation/Fragment Recovery
  1. Carefully excavate partially-buried marble headstone and sandstone base.
  2. Cut back vegetation.
- B. Cleaning
  1. For removal of biological growth and general soiling, clean the marble headstone and sandstone base with D/2 Architectural Antimicrobial.

- a. Clean water at low pressure (max 400 psi) and hand-pump sprayer.
    - b. Natural and nylon bristle brushes (varying stiffness and size).
    - c. Avoid dissolution or erosion of the stone.

2. Remove debris from original pin holes in headstone and base.
- C. Re-attachment and Repair
- D. Reset and Level
  1. Reset sandstone base upon compacted gravel.

2. Reset and plumb marble headstone on sandstone base utilizing existing pin holes. Use threaded stainless steel pins set in grout and set headstone on a thin bed of lime-based mortar.

- E. Site Preparation and Repair
  1. Place pea gravel around base
