MARKER No. 15: MARGARET THOMSON (d. 1853) daughter of P. & H. Thomson

EXISTING CONDITIONS

TREATMENT SUMMARY

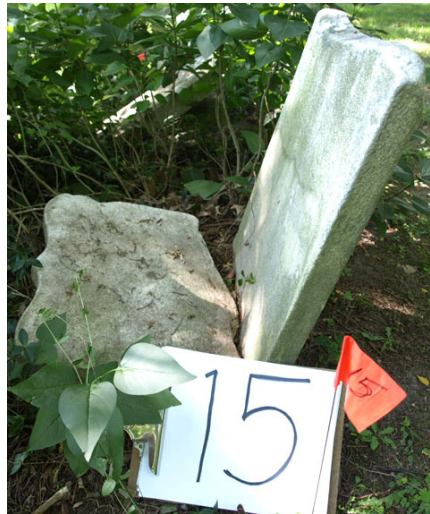
Before (July 2009)

- The marble headstone is in poor condition as it is broken into two (2) fragments and there is slight material loss around the fracture line (marble also appears to be friable and soft around fracture line). Inscriptions are partially legible.
- The bottom headstone fragment is leaning in the ground, shored up by non-original concrete berm. The upper fragment is lying on the ground in a horizontal position, surrounded by overgrown vegetation.
- The headstone fragments are experiencing biological growth and slight staining.
- Partially-buried sandstone base fragments are visible near the marker.

1. Carefully remove concrete berms and remove headstone fragments from ground.
2. Cut back vegetation.
3. Search for sandstone base fragments.
 - ▶ six base fragments were recovered (with the exception of some minor losses, these fragments formed a complete base).

1. For removal of biological growth and general soiling, clean the marble headstone and sandstone base fragments with D/2 Architectural Antimicrobial.
 - a. Clean water at low pressure (max 400 psi) and hand-pump sprayer.
 - b. Natural and nylon bristle brushes (varying stiffness and size).
 - c. Avoid dissolution or erosion of the stone.

1. If recovered, re-attach sandstone base fragments using two-part stone epoxy and threaded stainless steel pins.
 - ▶ the resultant seams were pointed/patched with a custom-mixed Type N mortar.
2. Re-attach two marble headstone fragments using two-part stone epoxy and threaded brass rods.
 - a. Point and infill where necessary around attachment seam with custom-mixed, lime-based, marble repair mortar (Type O mortar with marble dust).
 - ▶ removed concrete berms from marble marker (some minor spalls occurred during removal).
 - ▶ cracks and losses along a “line” at the bottom of the marker were filled with milk of lime and lime slurry.
 - ▶ some larger cracks and a small spall near the attachment seam were injected with a solution of B-72 resin.
