MARKER No. 17: MURVILLE HICKOX (d. 1861)

EXISTING CONDITIONS

TREATMENT SUMMARY

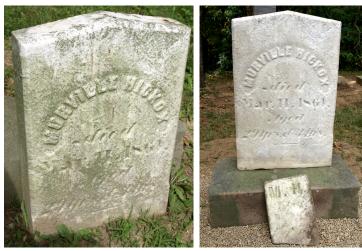
Before (July 2009)

- The marble headstone is in good condition and is experiencing slight biological growth and staining, and slight surface erosion. The inscriptions are legible.
- The marble headstone is no longer attached to its sandstone base and is currently partially buried in an upright position next to its sandstone base. The headstone was originally attached to its base with two metal pins and a thin bed of mortar.
- The sandstone base is in good condition with slight biological growth and staining. Its original pin holes are intact.

- A. Excavation/Fragment Recovery
 - 1. Carefully excavate partially-buried marble headstone and sandstone base.
- B. Cleaning
 - 1. For removal of biological growth and general soiling, clean the marble headstone and sandstone base with D/2 Architectural Antimicrobial.

- a. Clean water at low pressure (max 400 psi) and hand-pump sprayer.
 - b. Natural and nylon bristle brushes (varying stiffness and size).
 - c. Avoid dissolution or erosion of the stone.

- 2. Remove debris from original pin holes in headstone and base.
- C. Re-attachment and Repair
- D. Reset and Level
 - 1. Reset and level sandstone base upon compacted gravel.

- 2. Reset and plumb marble headstone on sandstone base utilizing existing pin holes. Use threaded stainless steel pins set in grout and set headstone on a bead of setting compound.

- ▶ marble footstone fragment (*M*. *H*.) set against front of base.
- E. Site Preparation and Repair
 - 1. Place pea gravel around base
