MARKER No. 19: ???

EXISTING CONDITIONS

TREATMENT SUMMARY

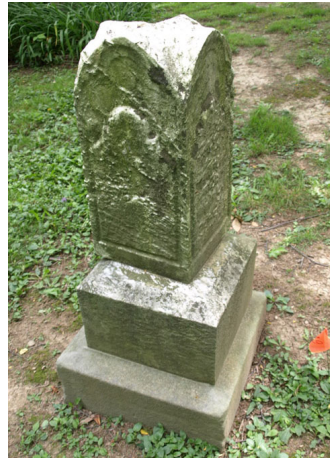
Before (July 2009)

- The upper crowned portion of the marble marker is in poor condition. It is experiencing severe biological growth and staining and surface erosion (dissolution). The design is somewhat disfigured and the inscriptions are not legible.
- The upper portion is displaced on its marble plinth and is overhanging on two sides (appears to be no pins or mortar).
 - ▶ the upper portion of the marker is bound to the plinth with epoxy (old repair attempt).
- The marble plinth and sandstone base are in good condition and are experiencing biological growth and staining.

1. For removal of biological growth and general soiling, clean the marble monument and sandstone base with D/2 Architectural Antimicrobial.
 - a. May require additional stone cleaning products (neutral) and multiple applications.
 - b. Clean water at low pressure (max 400 psi) and hand-pump sprayer.
 - c. Natural and nylon bristle brushes (varying stiffness and size).
 - d. Avoid dissolution or erosion of the stone.

- ~~1. ALT M19-1: It may be prudent to explore the possibility of consolidating the upper portion of the marble marker (with a natural lime based solution) and/or the application of a water repellent (this treatment is not included in base scope of work).~~
 - ▶ because the upper portion of the marker is bound to the plinth with epoxy, and remedial attempts to remove it in the field could cause damage, the marker was not treated at this time. *It is recommended that a monument company remove the marker to their shop and cut it apart using large specialized masonry saws.*

- ~~1. Reset upper portion of marker level and plumb upon existing marble plinth.~~
 - ~~a. Reset in a bed of lime & cement slurry with a threaded stainless steel pin.~~
 - ▶ because the upper portion of the marker is bound to the plinth with epoxy, and remedial attempts to remove it in the field could cause damage, the marker was not treated at this time. *It is recommended that a monument company remove the marker to their shop and cut it apart using large specialized masonry saws.*
