**MARKER No. 20: FLORANCE I. SNYDER (d. 1859) daughter of M. & S. Snyder**

**EXISTING CONDITIONS**

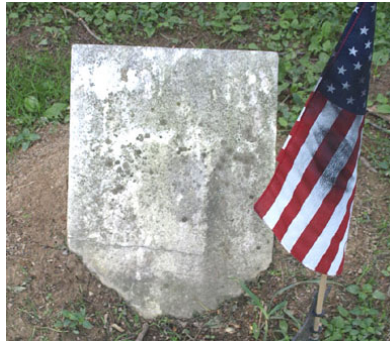
- The marble marker is in fair/poor condition. The marker does not appear to be attached to a base and is partially buried and leaning over to the west (on a pile of dirt from earth-boring insects). The inscriptions are on the west side of the marker and difficult to see.
- There is a transverse crack just below the inscription area.
- A non-original concrete berm is located to the east of the base.
- No visible evidence of an original sandstone base.

*Before (July 2009)*

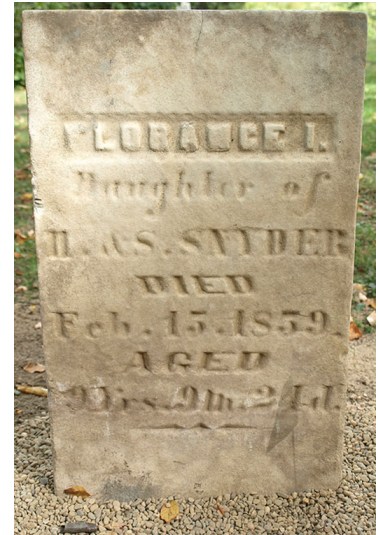
*After (September 2009)*

1. Carefully excavate partially-buried headstone.
2. Remove non-original concrete berm.
3. Search for sandstone base.

1. For removal of biological growth and general soiling, clean the marble headstone with D/2 Architectural Antimicrobial.
  - a. Clean water at low pressure (max 400 psi) and hand-pump sprayer.
  - b. Natural and nylon bristle brushes (varying stiffness and size).
  - c. Avoid dissolution or erosion of the stone.

1. Reset headstone at the proper level in the ground in a mix of fine gravel, sand, cement, and hydrated lime.
  - a. Place brick or pieces of stone in hole for additional support.

1. Place pea gravel around base
