**MARKER No. 23: MATILDA ROSE HICKOX (d. 1888) wife of Giles Hickox**

**EXISTING CONDITIONS**

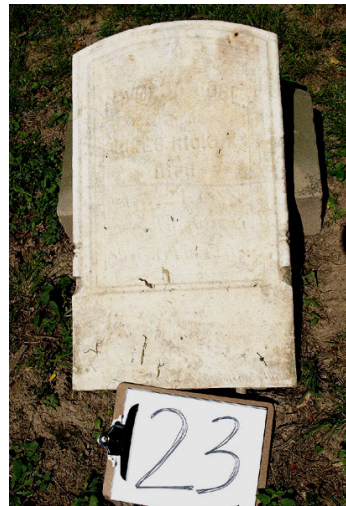
- The marble headstone is in good condition and is experiencing very slight biological growth and staining, and very slight surface erosion. The inscriptions are legible.
- The marble headstone is no longer attached to its sandstone base and is currently canted on the ground against its sandstone base. The headstone was originally attached to its base with two metal pins and a thin bed of mortar. Two original metal pins remain in the marble headstone.
- The sandstone base is in good condition with slight biological growth and staining. Its original pin holes are still intact. The sandstone base is not buried at a proper depth.

*Before (July 2009)*

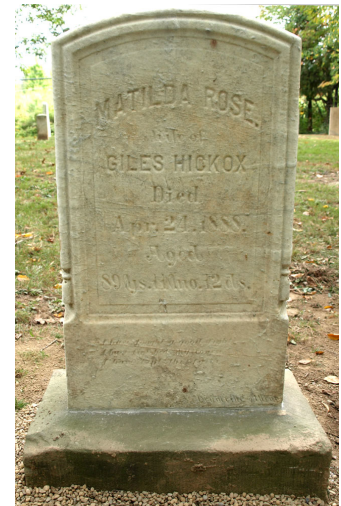
*After (September 2009)*

- A. Excavation/Fragment Recovery
1. Remove marble marker and sandstone base to a safe location for cleaning.
  2. Excavate for preparation of a compacted gravel foundation.

- B. Cleaning
1. For removal of biological growth and general soiling, clean the marble headstone and sandstone base with D/2 Architectural Antimicrobial.

- a. Clean water at low pressure (max 400 psi) and hand-pump sprayer.
    - b. Natural and nylon bristle brushes (varying stiffness and size).
    - c. Avoid dissolution or erosion of the stone.

2. Remove debris from pin holes in sandstone base.
- C. Re-attachment and Repair
- D. Reset and Level
1. Reset sandstone base to a proper depth upon a foundation of compacted gravel. Ensure top of sandstone base is level.

2. Reset and plumb marble headstone on sandstone base utilizing existing pins and holes. Set headstone on a thin bed of lime-based mortar.
- E. Site Preparation and Repair

1. Place pea gravel around base
