**MARKER No. 24: WHITE MONUMENT – Hosea: 1876; Nancy: 1878; Esther: 1880**

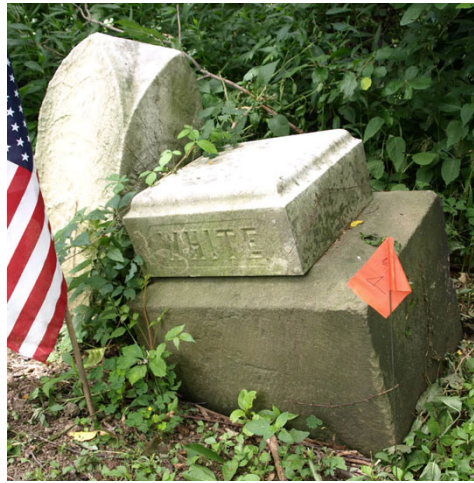
*Before (July 2009)*

- Overall, the monument is in fair condition, however, the upper crown portion is experiencing dissolution and surface loss. The inscriptions are mostly legible.
- The upper portion is no longer attached to its marble plinth and is resting in an upright position on the ground, next to its base; the marble plinth has shifted on its sandstone base (appears to be no pins or mortar).
- The monument has settled and is leaning to the southeast.
- Both the marble portions and the sandstone base are experiencing slight biological growth and staining and are surrounded by encroaching vegetation.
