MARKER No. 25: BEAMAN MONUMENT – Henry:1871; Phebe: 1879; William H: 1854

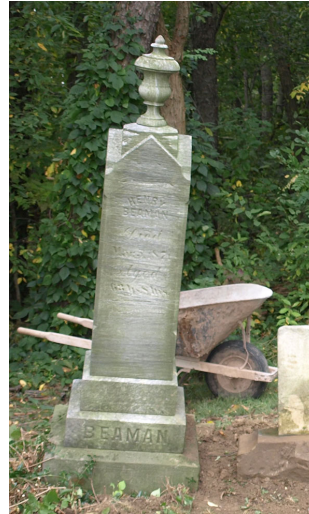
Before (September 2009)

- Overall, the monument is in good condition, however, the marble is experiencing slight dissolution and surface loss. The inscriptions are legible.
- The urn/finial has been re-attached with epoxy (old repair), however, it was not properly set and contains a gap at the joint.
- The monument has settled and has been displaced by vegetation growth and is leaning to the northeast.
- Both the marble portions and the sandstone base are experiencing slight biological growth and are surrounded by encroaching vegetation.

1. Cut back vegetation.
2. Carefully excavate around base in preparation for leveling and reinforcing the foundation.
 - ▶ remove encroaching root growth.

1. For removal of biological growth and general soiling, clean the marble portions and sandstone base with D/2 Architectural Antimicrobial.
 - a. Clean water at low pressure (max 400 psi) and hand-pump sprayer.
 - b. Natural and nylon bristle brushes (varying stiffness and size).
 - c. Avoid dissolution or erosion of the stone.

- ▶ the gap at the base of the urn/finial was pointed with setting compound.

1. Reset monument level and plumb.
 - ▶ the foundation was excavated to expose the outer area of the base and the monument was maneuvered into level and plumb with levers and a hydraulic jack.
 - ▶ the foundation was restored with compacted rocks, and a dry mix of lime, cement and sand.

1. The soil was replaced around the base.
