**MARKER No. 26:**

**EXISTING CONDITIONS**

**TREATMENT SUMMARY**

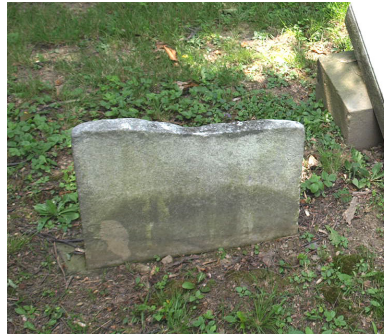
- The marker is in poor condition.
- The upper portion of the marble marker has broken off and its location is not currently known (the lower portion is secure in its sandstone base).
- The marble is severely weathered and sugaring, and the partial inscriptions are not legible.
- The monument has settled and the base is covered by deposition.
- The marble is experiencing slight biological growth and staining.

*Before (July 2009)*

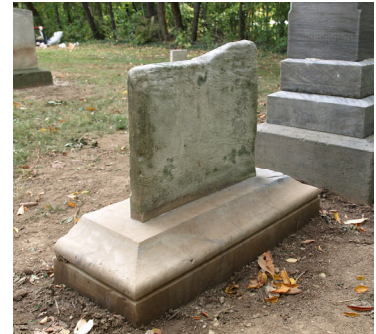
*After (September 2009)*

1. Cut back vegetation.
2. Carefully excavate around marker and remove from the ground.
3. Excavate ground in preparation for new compacted gravel foundation.
  - ▶ the upper portion of the marble marker was not located.
  - ▶ uncovered carved/moulded sandstone base

1. For removal of biological growth and general soiling, clean the marble portions and sandstone base with D/2 Architectural Antimicrobial.
  - a. Clean water at low pressure (max 400 psi) and hand-pump sprayer.
  - b. Natural and nylon bristle brushes (varying stiffness and size).
  - c. Avoid dissolution or erosion of the stone.

- a. Reset marker upon a foundation of compacted gravel to a depth which exposes the carved moulding detail. Ensure top of sandstone base is level.

1. Replace soil around base.
