MARKER No. 27: HARRIET BENNETT-KING (d. ?) wife of C. King / daughter of T.S. & R. Bennett

EXISTING CONDITIONS

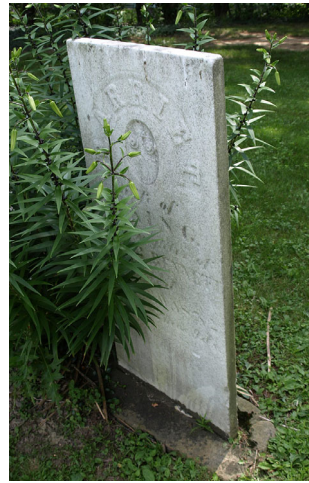
Before (July 2009)

- Overall, the marker is in good/fair condition, however, the marble is experiencing slight dissolution and surface loss.
- The marker has settled and is leaning to the east.
- The sandstone base is visible.
- The marble is experiencing slight biological growth and staining.
