MARKER No. 28: HATCH FAMILY GROUP – John, Permellia, John S, Laura E, James, Lydia N, Timothy W

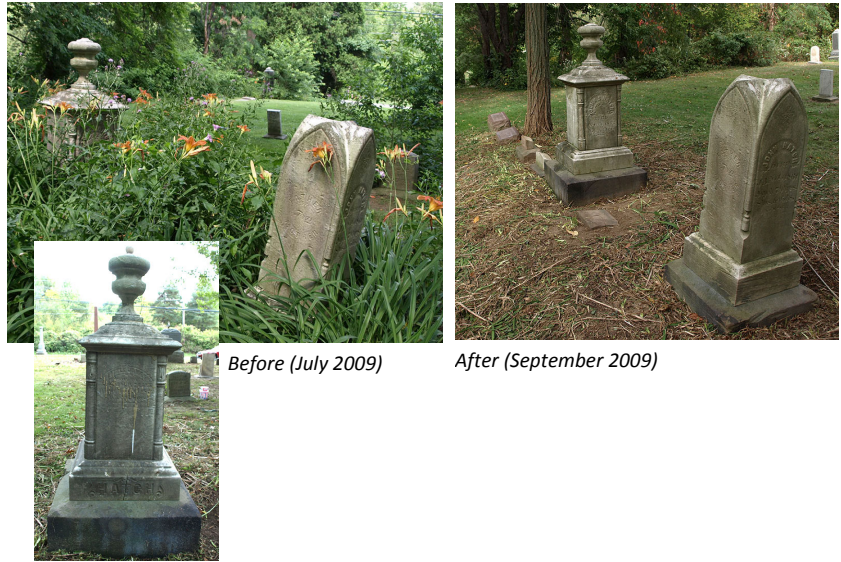
- Overall, the monuments are in fair condition. Both the monuments and the smaller markers are surrounded by encroaching vegetation. The monuments are leaning (the smaller markers are displaced as well).
- The individual “Father” marker is missing. The urn atop the larger monument is broken at its base and rests unsteadily in place.
- The marble monuments are experiencing minor surface dissolution and material loss. The inscriptions are mostly legible.
- There are epoxy drips and runs on the cap and down the face of the shaft (the result of a poorly-executed past repair).
- The marble and the sandstone bases are experiencing biological growth and staining.

- A. Excavation/Fragment Recovery
 1. Cut back vegetation.
 2. Search for missing “Father” marker.
 - ▶ missing marker not located.
- B. Cleaning
 1. For removal of biological growth and general soiling, clean with D/2 Architectural Antimicrobial.
 - a. Clean water at low pressure (max 400 psi) and hand-pump sprayer.
 - b. Natural and nylon bristle brushes (varying stiffness and size).
 - c. Avoid dissolution or erosion of the stone.
- C. Re-attachment and Repair
 1. Carefully remove the larger portions of the epoxy drips with small detailing hand tools.
 - ▶ the removal of the epoxy drips left “scars” from where the marble beneath was protected from soiling and small amounts of marble came off with the epoxy.
 - ▶ re-attached broken and loose marble finial in place with a thin bed of mortar (temporary repair).
- D. Reset and Level
- E. Site Preparation and Repair
