MARKER No. 29: UNKNOWN

EXISTING CONDITIONS

TREATMENT SUMMARY

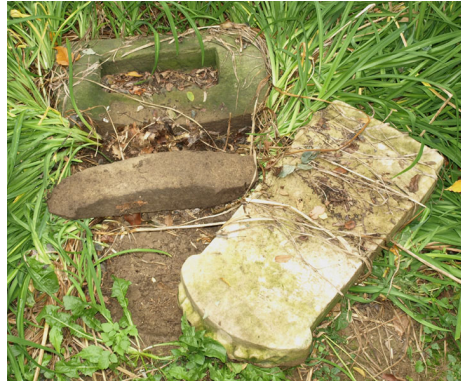
Before (July 2009)

- Overall, the marker is in fair condition, however, the marble portion is experiencing slight dissolution and surface loss. The inscriptions are no longer legible.
- The upper portion is no longer attached to its sandstone base and is resting face down on the ground.
- The front portion of the sandstone base has spalled and is lying next to the base.
- Both the marble portion and the sandstone base are experiencing slight biological growth and staining and are surrounded by encroaching vegetation.

- A. Excavation/Fragment Recovery
 - 1. Cut back vegetation.
- B. Cleaning
 - 1. For removal of biological growth and general soiling, clean the marble portion and sandstone base with D/2 Architectural Antimicrobial.
 - a. Clean water at low pressure (max 400 psi) and hand-pump sprayer.
 - b. Natural and nylon bristle brushes (varying stiffness and size).
 - c. Avoid dissolution or erosion of the stone.
- C. Re-attachment and Repair
 - 1. Re-attach sandstone base fragment using two-part stone epoxy and a threaded stainless steel rod.
 - a. Point resultant joints and losses with custom-mixed lime-based mortar.
- D. Reset and Level
 - 1. Reset marble marker in sandstone slot with a lime-based mortar slurry. Point joint with custom-mixed Type O mortar.
- E. Site Preparation and Repair
