MARKER No. 30:FRENCH FAMILY GROUP-Cyrus E:1883; Sarah J (Stebbins):1894; James H:1898; Timothy B:1874

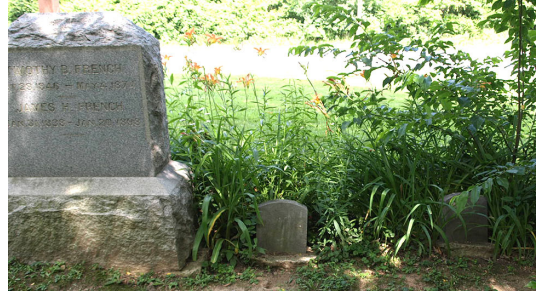
- Overall, the monuments and markers are in good condition (the larger granite monument is likely a contemporary replacement).
- The family group is surrounded by encroaching and invasive vegetation (there is extensive woody plant growth and root development at the north end of the group).
- The small individual markers are slightly displaced and leaning to the east.
- The northern-most marker appears to be military issue, however, the inscriptions are not legible.

Before (July 2009)

- A. Excavation/Fragment Recovery
 - 1. Cut back vegetation.
- B. Cleaning
 - 1. ~~For removal of biological growth and general soiling, clean the marble portions and sandstone base with D/2 Architectural Antimicrobial.~~
 - ▶ dry brush markers after cutting back vegetation.
- C. Re-attachment and Repair
 - ▶ assess and document condition of monument and markers.
- D. Reset and Level
- E. Site Preparation and Repair

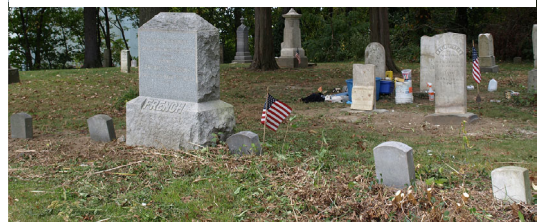
After (September 2009)
