## MARKER No. 12: WM. R.H. AVERY (d. 1879)

### EXISTING CONDITIONS

### TREATMENT SUMMARY

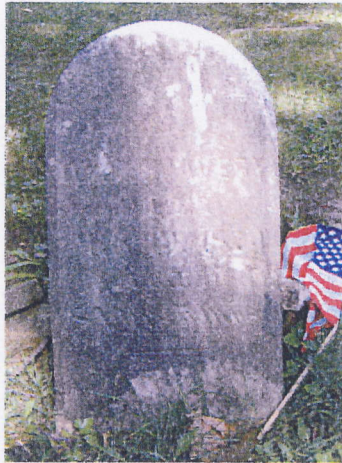
Before (July 2008)

- The marble headstone is in good condition and the inscriptions are legible. The headstone is not currently set in a solid base and is leaning over.
- The headstone is experiencing biological growth and slight staining.
- There are broken concrete berms at the base of the headstone.
- There are remnants of sandstone fragments.

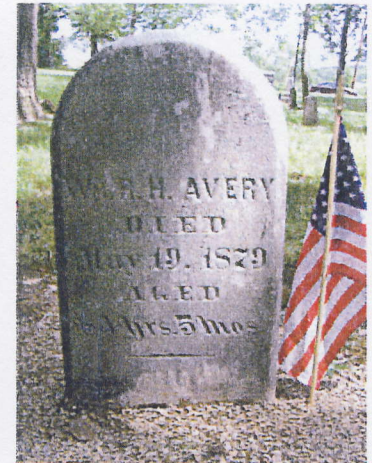
After (May 2009)

1. For removal of biological growth and general soiling, the marble headstone was cleaned with D/2 Architectural Antimicrobial.
    - a. Clean water at low pressure (max 300 psi) and hand-pump sprayer.
    - b. Natural or nylon bristle brushes (varying stiffness and sizes).
    - c. Avoid dissolution or erosion of the stone.
- stone was successfully cleaned, however, slight biological staining and discoloration remain, which cannot be removed without harsh methods.

► base fragments for this headstone not found
2. If sandstone base is not recovered, reset marble headstone in the ground, at proper depth, in a mixture of gravel, sand, cement, and hydrated lime.

► pieces of stone were placed in the bottom of the hole for foundation.

1. Remove concrete berms from marble headstone.
2. Remove headstone from ground.
3. Search for base.

► base fragments for this headstone were not found; however, a slotted sandstone base is partially buried nearby and could be this headstone's original base. The marble headstone was not mated to the sandstone base at this time due to lack of documentation regarding original locations.
