**MARKER No. 13: MARY AVERY (d. 1853) wife of WM. R.H. Avery**

**EXISTING CONDITIONS**

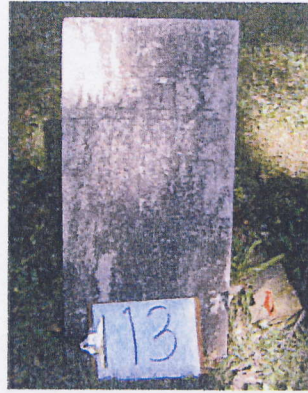
*Before (July 2008)*

- The marble headstone is in good condition and the inscriptions are partially legible. The headstone is not currently set in a solid base and is leaning over.
- The headstone is experiencing biological growth and staining.
- Concrete berm at the base of the east face.
- Remnants of a sandstone base are present.

1. Remove concrete berms from marble headstone.
2. Remove headstone from ground.
3. Search for base.
  - ▶ miscellaneous sandstone fragments were found (possibly base fragments).

1. For removal of biological growth and general soiling, the marble headstone was cleaned with D/2 Architectural Antimicrobial.
  - a. Clean water at low pressure (max 300 psi) and hand-pump sprayer.
  - b. Natural or nylon bristle brushes (varying stiffness and sizes).
  - c. Avoid dissolution or erosion of the stone.
    - ▶ stone was cleaned, however, biological staining and discoloration remain.
    - ▶ it is recommended that additional cleaning efforts be carried out (test different products and methods).

1. If recovered, re-attach sandstone base fragments using two-part stone epoxy and stainless steel or nylon pins.
  - ▶ sandstone fragments were recovered, however, not enough to reconstruct a complete base. Because the recovered fragments were incomplete, and due to lack of physical evidence and documentation, the sandstone base was not reconstructed at this time. Sandstone fragments were retained on site.
  - ▶ It is recommended that the fragments be properly buried in a geotextile pocket next to marble headstone.

1. If sandstone base is recovered and repaired, reset base at proper depth upon compacted gravel and set marble headstone into slotted sandstone base with a Type O mortar mix.
  - ▶ sandstone base not reconstructed at this time.
2. If sandstone base is not recovered, reset marble headstone in the ground, at proper depth, in a mixture of gravel, sand, cement, and hydrated lime.
  - ▶ pieces of stone were placed in the bottom of the hole for foundation.
