## MARKER No. 15: THOMAS W. CHASE (Child - d. 1860)

### EXISTING CONDITIONS

### TREATMENT SUMMARY

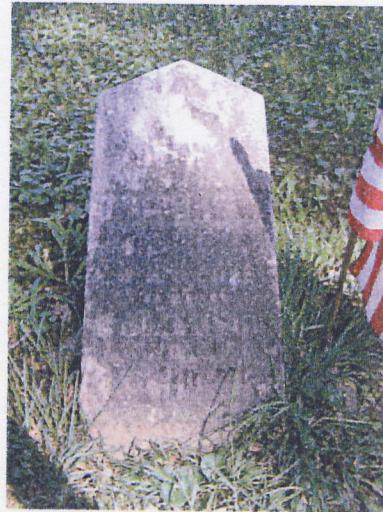
Before (July 2008)

- The marble headstone is in good condition and the inscriptions are legible. The headstone is not currently set in a solid base and is leaning over.
- The headstone is experiencing biological growth and staining.
- Remnants of a sandstone base are present.

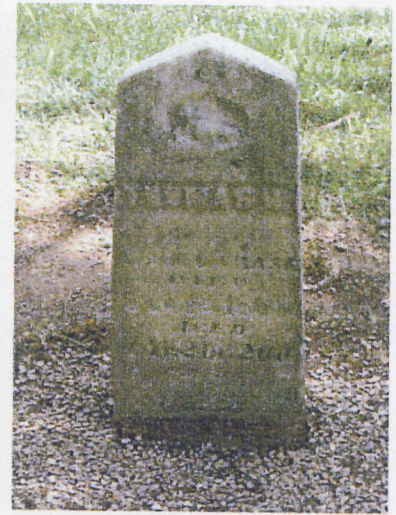
After (May 2009)

- ▶ stone was successfully cleaned, however, slight staining and discoloration remain, which cannot be removed without harsh methods.
- C. Re-attachment and Repair

- ▶ marble headstone was reset in the ground, at proper depth, in a mixture of gravel, sand, cement, and hydrated lime (pieces of stone were placed in the bottom of the hole for foundation).

- A. Excavation/Fragment Recovery
1. Remove headstone from ground.
  2. Search for base.
    - ▶ base not located.
- B. Cleaning
1. For removal of biological growth and general soiling, the marble headstone was cleaned with D/2 Architectural Antimicrobial.

- a. Clean water at low pressure (max 300 psi) and hand-pump sprayer.
    - b. Natural or nylon bristle brushes (varying stiffness and sizes).
    - c. Avoid dissolution or erosion of the stone.

- ▶ base not located.
  2. If sandstone base is not recovered, site-cast a new concrete base and attach marble headstone with stainless steel rods and a thin bed of mortar.
