## **MARKER No. 08: HAMILTON FAMILY**

### **EXISTING CONDITIONS**

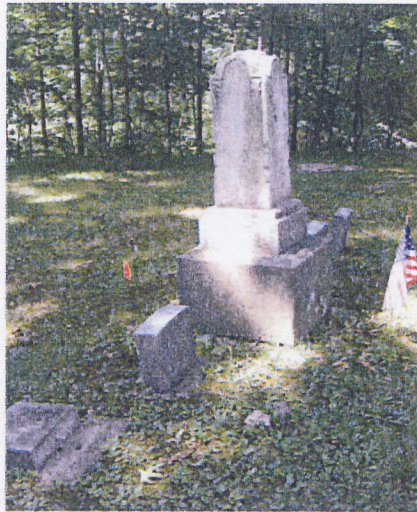
*Before (July 2008)*

- The marble and sandstone monument is in good condition.
- The marble portion is experiencing minor biological growth and staining. There has been a slight loss of detail and inscription due to minor surface erosion. The ornamental stone finial is missing.
- Sandstone base is in good condition with slight biological growth and staining.
- The monument has been displaced from the ground and is no longer set at its proper depth.

- ▶ dismantled main monument (3 pieces) and lift base.
- ▶ excavated to proper depth (several small stone boulders and slabs were removed).
- ▶ excavate and lift four (4) adjacent small markers.

1. For removal of biological growth and general soiling, the marble monument and base were cleaned with D/2 Architectural Antimicrobial.
  - a. Clean water at low pressure (max 300 psi) and hand-pump sprayer.
  - b. Natural or nylon bristle brushes (varying stiffness and sizes).
  - c. Avoid dissolution or erosion of the stone.
  - ▶ stones were successfully cleaned, however, slight biological staining and discoloration remain, which cannot be removed without harsh methods.
  - ▶ the four (4) adjacent small markers and bases were also cleaned.

1. Reset monument to proper depth on a base of compacted gravel. Monument shall be level and plumb.
  - ▶ sandstone base reset on a new foundation consisting of gravel, sand and a dry mix of lime and cement which was compacted and leveled.
  - ▶ marble plinth reset upon sandstone base with lime-based slurry (1:1:4 mix with fine silica sand).
  - ▶ marble shaft reset upon plinth with lime-based slurry and a single stainless steel threaded rod in grout.
  - ▶ small marker bases were raised and reset level on a bed of gravel and sand.
  - ▶ the small markers were reset on leveled bases with lime-based slurry (the existing metal pins were removed, cleaned, and re-installed with grout).

- ▶ it is recommended that the missing urn/finial be reproduced and installed (new marble or cast stone).
