MARKER No. 07: WILLIAM EGLIN (d. 1846) son of Wm & M Eglin

TREATMENT SUMMARY

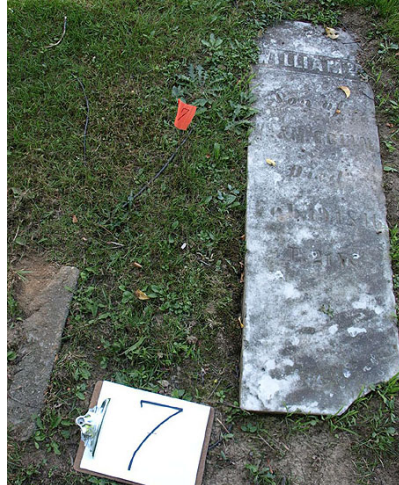
Before (July 2009)

- The marble headstone is in fair/poor condition and is experiencing staining, biological growth, and slight surface erosion
- The marble headstone has a broken lower corner and is no longer on its sandstone base and is partially buried in a horizontal position.
- Possible sandstone base partially buried adjacent to location of headstone.
