MARKER No. 08: LYMAN HOLMES (d. 1856)

TREATMENT SUMMARY

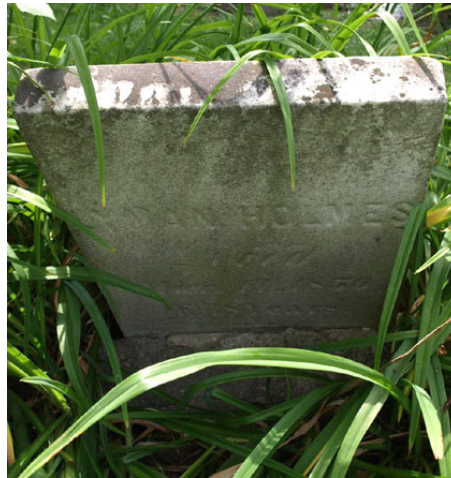
Before (July 2009)

- The marble headstone is in fair condition and is experiencing staining, biological growth, and slight surface erosion.
- The marble headstone is not currently set in a proper base and is leaning over.
- Severe vegetation encroachment.
- There are remnants of marble fragments (may be a footstone) and non-original concrete berms at the base
- No evidence of an original proper base.
