MARKER No. 16: FRANK HICKOX (child d. 1850) son of J.G. & E.J. Hickox

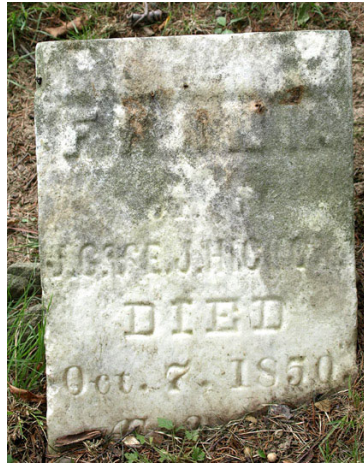
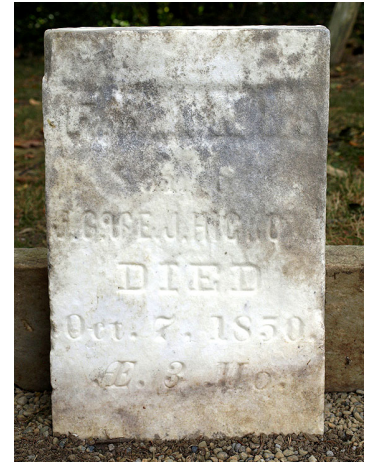
- The marble headstone is in fair condition and is experiencing slight biological growth and staining. There is some slight surface erosion near the top of the marker, however, the marker is sound and the inscriptions are legible.
- The marble marker is no longer upright on a base and is currently partially buried and leaning over with the upper portion resting on what appears to be sandstone base fragments.

1. Carefully remove marble headstone from ground.
2. Search for and carefully excavate sandstone base fragments.
 - ▶ a foreign marble footstone was recovered (*E.H.*)
 - ▶ sandstone fragments were found, however, they did not constitute a base.

1. For removal of biological growth and general soiling, clean the marble headstone and sandstone base fragments with D/2 Architectural Antimicrobial.
 - a. Clean water at low pressure (max 400 psi) and hand-pump sprayer.
 - b. Natural and nylon bristle brushes (varying stiffness and size).
 - c. Avoid dissolution or erosion of the stone.

1. ~~If sandstone base is recovered and repaired, reset base at proper depth upon a new compacted gravel foundation and set marble headstone into slotted sandstone base with a Type O mortar mix, or~~
2. If sandstone base is not recovered, reset marble headstone in the ground, at proper depth, in a mixture of fine gravel, sand, cement, and hydrated lime.
 - a. Place brick or pieces of stone in hole for additional support.

1. Place pea gravel around base
