**MARKER No. 18: HAIGHT MONUMENT – Ransom S: 1852; Andrew P: 1872; Susan M: 1907**

**EXISTING CONDITIONS**

**TREATMENT SUMMARY**

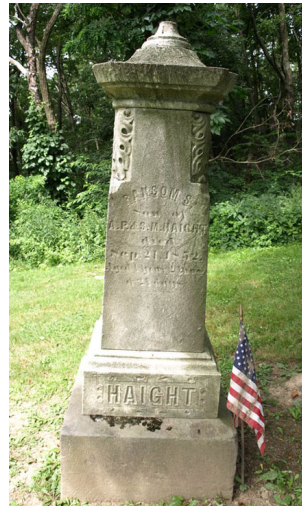
Before (July 2009)

- The marble and sandstone monument is in good condition. The monument's urn/finial is missing.
- The marble portion is experiencing minor biological growth and staining. There has been a slight loss of detail and inscription due to minor surface erosion. The inscriptions are legible.
- Sandstone base is in good condition with slight biological growth and staining.
- The monument has settled and is sinking and leaning to the northwest.
- There is a foreign marble marker leaning against the monument (John G. Whght – d. 1845). Its original location is not currently known. This marker should be handled with caution as it has a transverse crack at its midpoint which continues through the marker via a vein to the back side.
